REMEDIAL SITE ASSESSMENT DECISION – EPA Region 05

Site Name: ESSEX WIRE - ROCKFORD

Title: CERCLA Site Reassessment for Essex Wire - Rockford

**CERCLA
SITE INSPECTION**

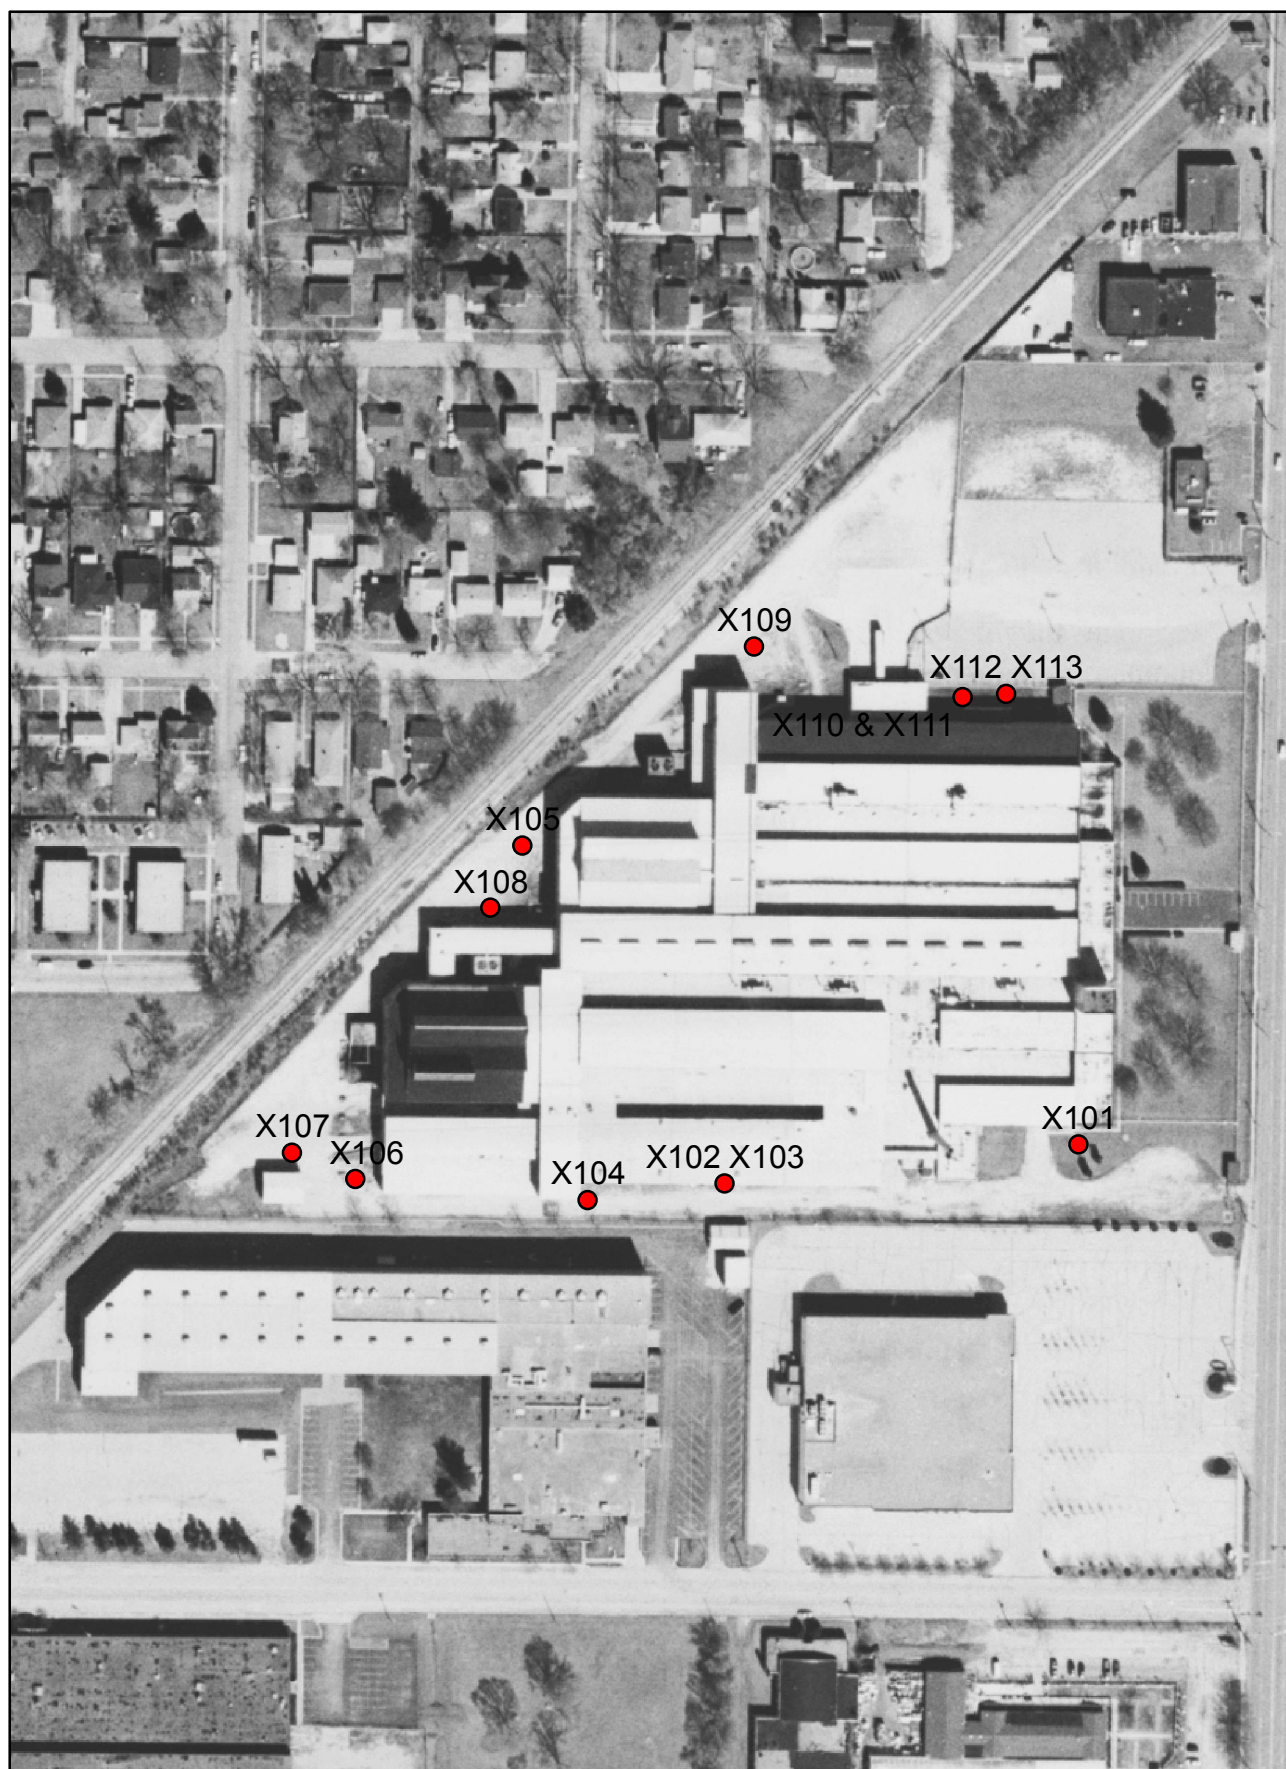
Figure 5: Soil Sample Map

Thirteen soil samples were collected from various locations on site. X101 was collected from the southeast corner of the property in the area of a former underground storage tank (UST). X102 and X103 was collected along the south side of the building. X104 was collected on the south side of the building near the intersection of buildings (where a new area of buildings begins). X106 was collected at the

southwest corner of the building near a loading dock area. X107 was collected on the north side of the small building which was utilized for storage. X108 was collected on the west side of the facility near a large garage door opening. X105 was collected in an area on the west side of the building near the area of ventilation for the hot forge shop. X109 was collected on the northern portion of the property and was to be utilized as a background sample. X110 –X113 were collected on the north side of the building in an area near the former chip house. Sample locations are depicted in Figure 5.

Soil sample results indicated elevated levels of several inorganics. The soil samples described in this section exceeded three times the background concentration. Samples X108, X110 and X111 had elevated levels of antimony. X110 had 15.7 ppm of arsenic, 2.6 ppm of cadmium, 94800 ppm iron, 98 ppm lead and 6.4 ppm for silver. A table containing the inorganic and organic analysis of the soil samples can be found in Table 2 and 3.

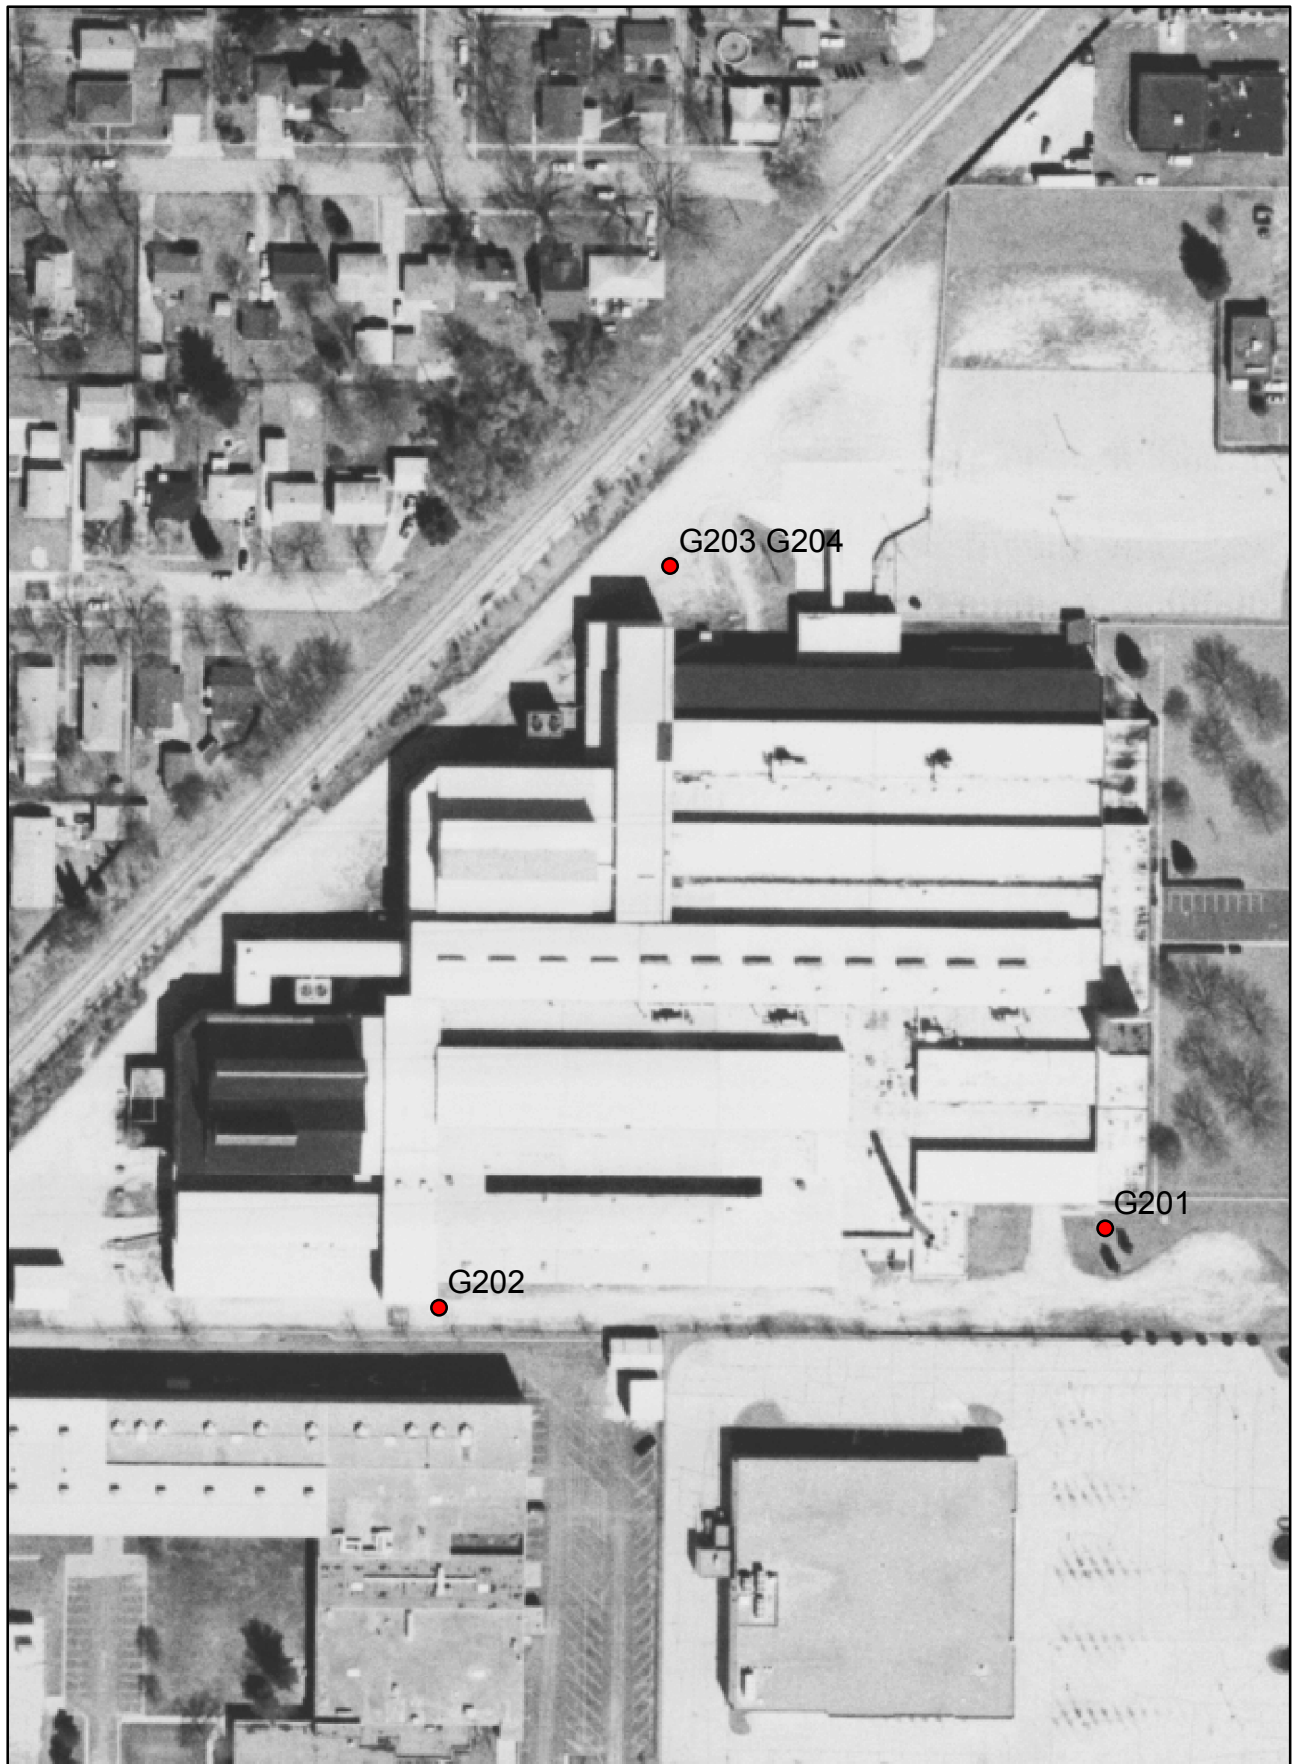
Figure 6: GW Location Map

Four groundwater samples were collected during the Site Investigation from three locations. G201 was collected near the southeast corner of the facility in the area of a former UST. G202 was collected on the south side of the facility. This location was chosen due to the suspected groundwater flow to the south. G203/G204 was collected from the northern portion of the property. This area was selected to represent background concentrations. Sample locations are depicted in Figure 6.

The only groundwater organic exceedance was for trichloroethene and cis-1,2-dichloroethene in G202. Trichloroethene (15 parts per billion) exceeded the associated MCL value of 5 parts per billion. Inorganic groundwater data revealed elevated levels of chromium, manganese and nickel in G202 (Table 4).

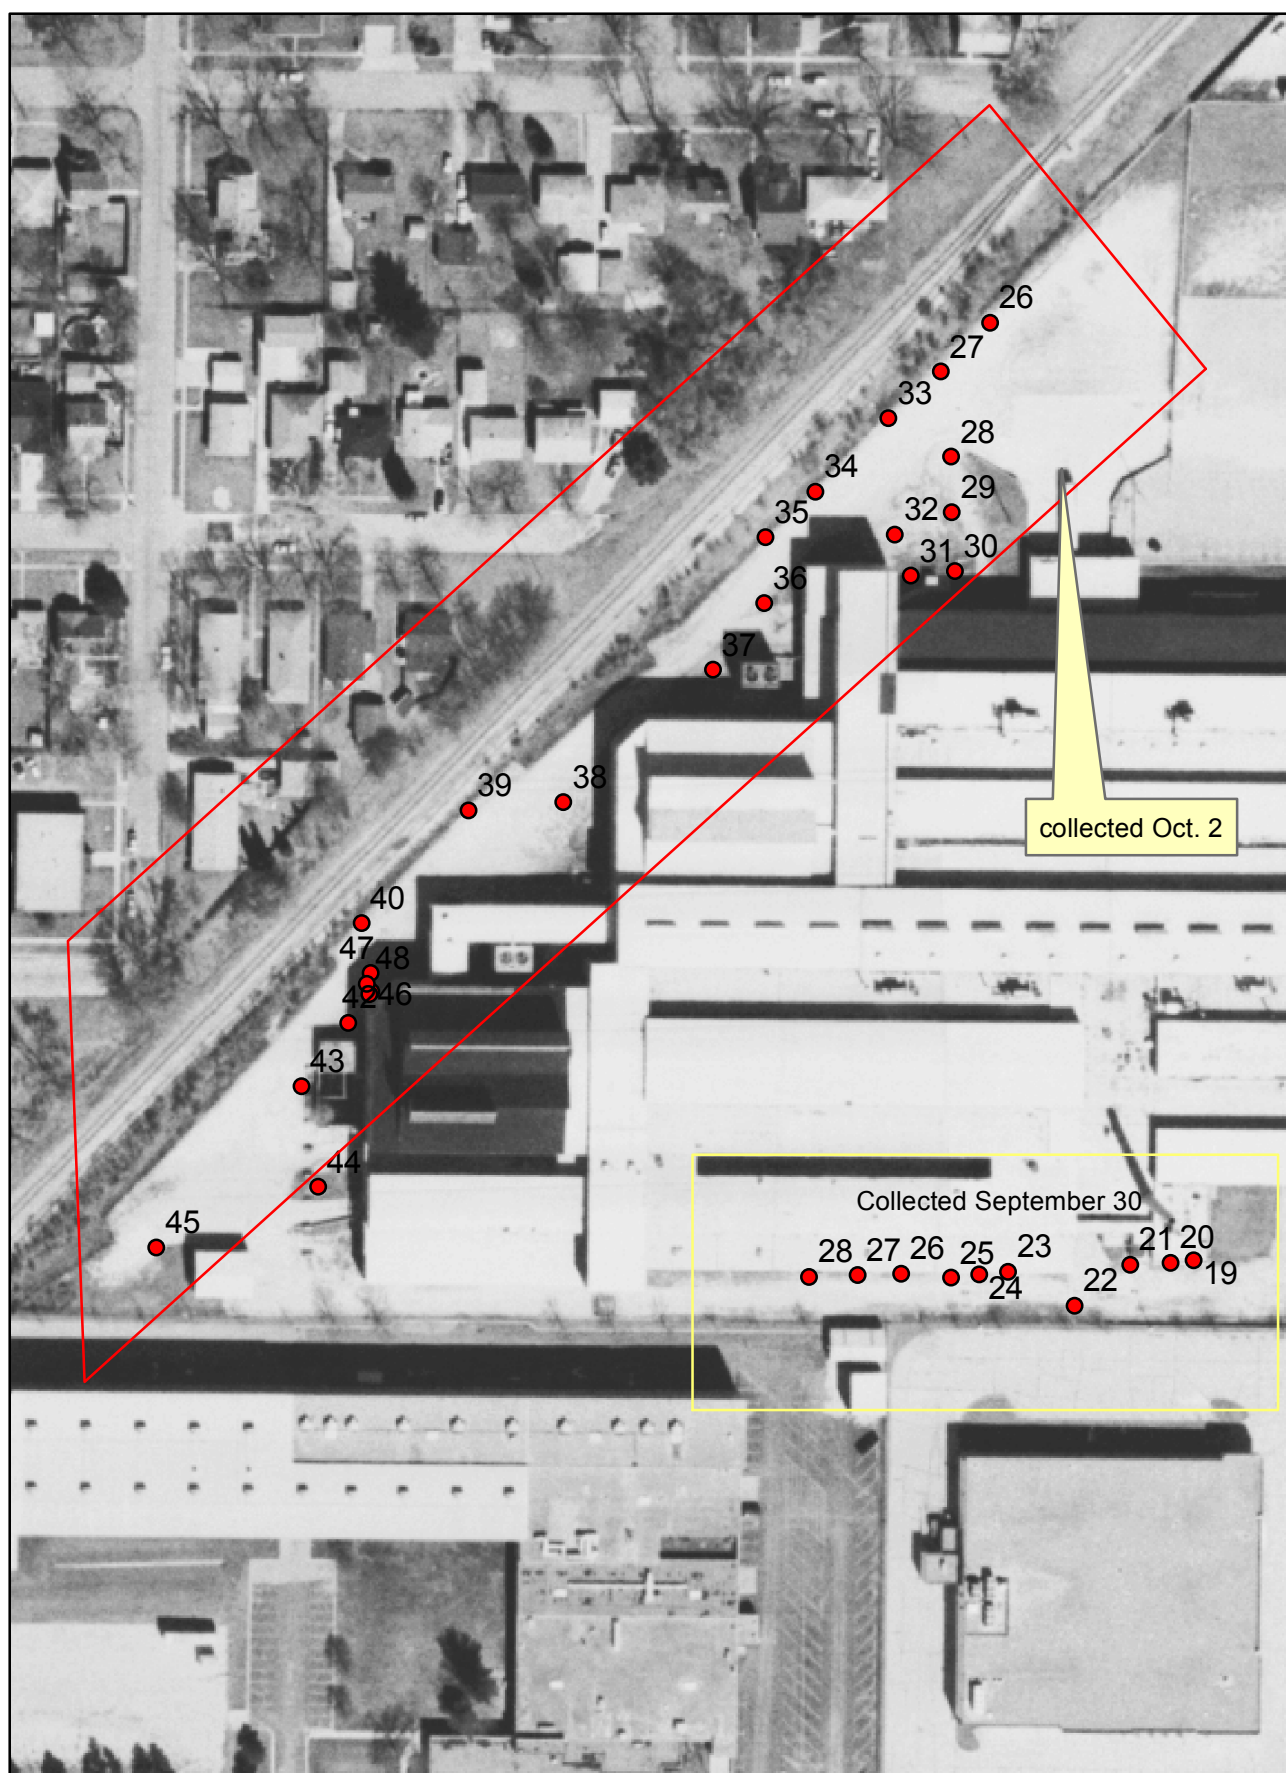
Figure 7: XRF Locations

X-Ray Fluorescence (XRF) data was collected to determine if inorganic contamination was present in the onsite soils near the smokestack and near the venting system located on the west side of the building. Two locations revealed elevated lead above 400 ppm at 448 and 854 ppm. The complete XRF data set can be found in Table 5. XRF sample locations can be found in Figure 7.
